Boyer, Brian E. and Kenneth Brodnax, 1996. *Oil and Gas Production Emission Factors and Estimation Methods*. Complete Oil Field Management and Maintenance, Inc., Lafayette, Louisiana, and Mobil Exploration and Production Company, Houston, Texas. Presented at the Emission Inventory: Key to Planning Permits, Compliance and Reporting Conference, Air and Waste Management Association, September 4-6, 1996, New Orleans, Louisiana.

Inspection took place on 4/3/18 between 8:00 am - 10:00 am  
All first attempt repairs were made by warrior crew and roustabout  
Leaks were detected within the closed vent system

## Method 22 Inspection Form

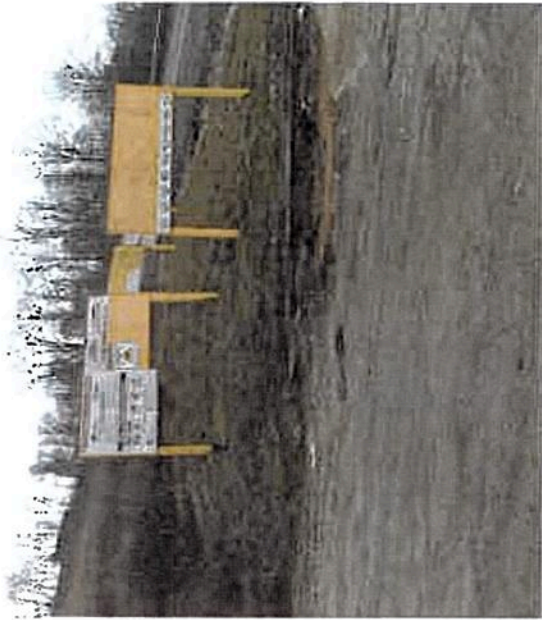
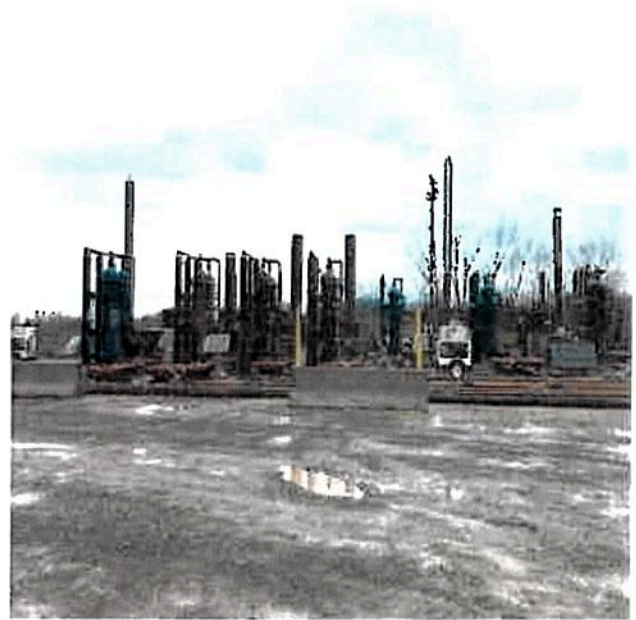
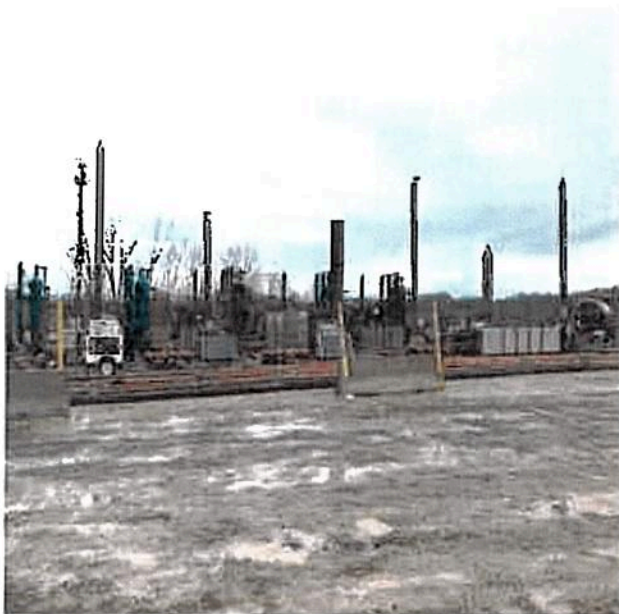
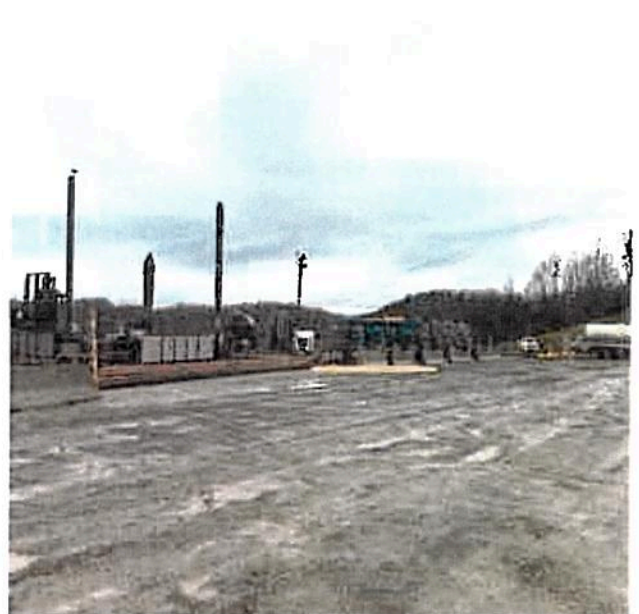
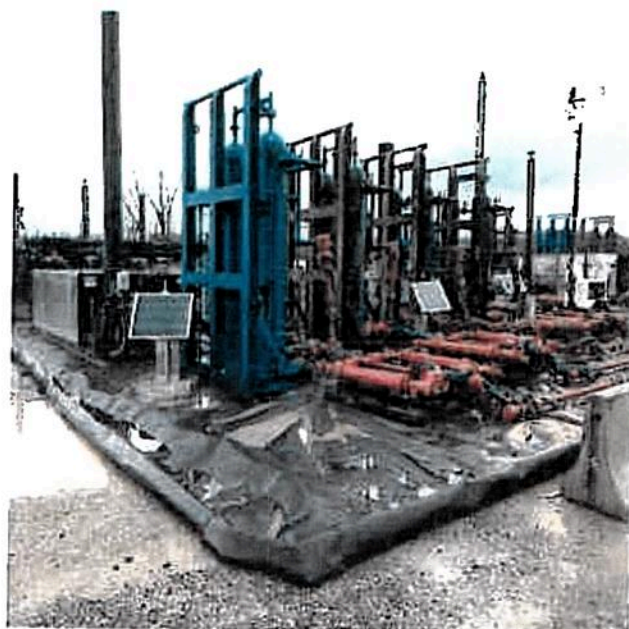
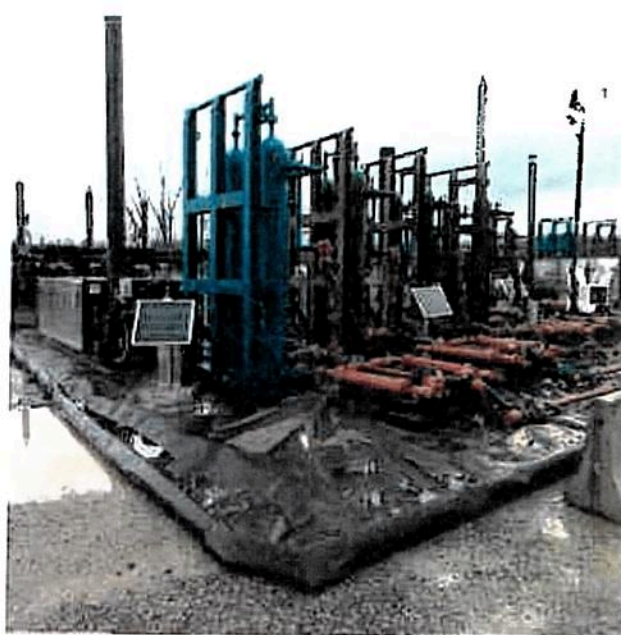
- GPU Brocade 1H gas out line hammer union threads leaking WO # 20588167

- Tank 14 enardo leaking

- GPU Burlington 1H stainless connection between butterfly valves

- GPU Manzarek 2H stainless connection into butterfly valve

WO# 20588167 Repair made on 4/5/18 and re-monitored on 4/5/18. No leak was detected work order closed.

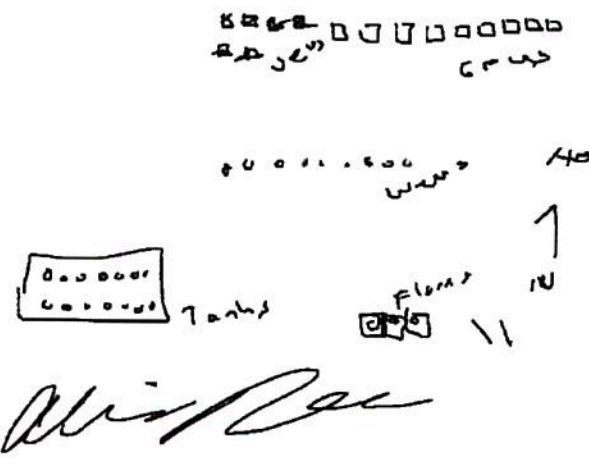
Clock Time	Observation period duration (minutes)	Duration visible emissions (minutes)	Drawing
11:00 AM	1	0

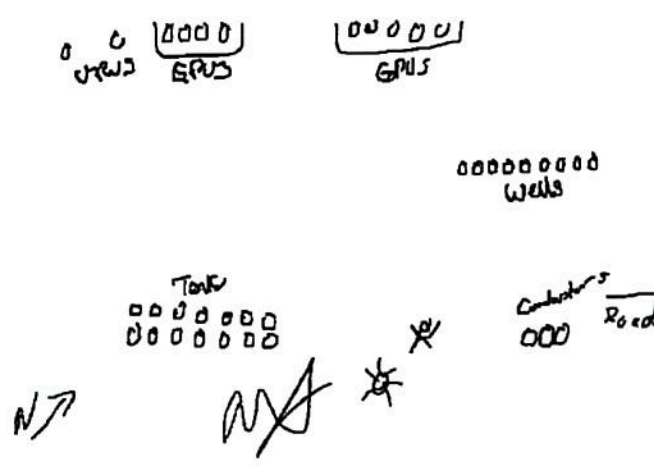
Clock Time	Observation period duration (minutes)	Duration visible emissions (minutes)	Drawing
10:00 AM	1	0
